Project/Site: Garnet	City/County: Cato, Cayuga	Sampling Date: 2020-June-23
Applicant/Owner: NextEra	State: NY	Sampling Point: W-NSD-14; PFO-1
Investigator(s): Nick DeJohn, Ryan Snow	Section, Township, Range:	
Landform (hillslope, terrace, etc.): Depression	Local relief (concave, convex, none):	Concave Slope (%): 0-1
Subregion (LRR or MLRA): LRR L	Lat: 43.150627051 Long:	-76.6232360279 Datum: WGS84
Soil Map Unit Name: Ontario fine sandy loam, 8	to 15 percent slopes	NWI classification:
Are climatic/hydrologic conditions on the site typic	al for this time of year? Yes No _∠ (If no	, explain in Remarks.)
	significantly disturbed? Are "Normal Circums naturally problematic? (If needed, explain ar	stances" present? Yes 🟒 No ny answers in Remarks.)

WETLAND DETERMINATION DATA FORM - Northcentral and Northeast Region

am moentory Data 10	
Project Name: Garnet Energy Cen	er Observer Nam	ne: BF/RS
Project Number:	Date:6/2	
Map Sheet No.:	State/County:	NY/Cayuga
GPS Point No(s):	Weather:	Clear
Associated Data Sheet		on (address, nearest road, structure etc.)
No(s):	Koule 3	8 Conquest, NY
	Stream Information	
	Stream Width	: <u>2-6</u> ft.
Stream Name: BF-S1	Water Width	<u> </u>
Perceptible Flo

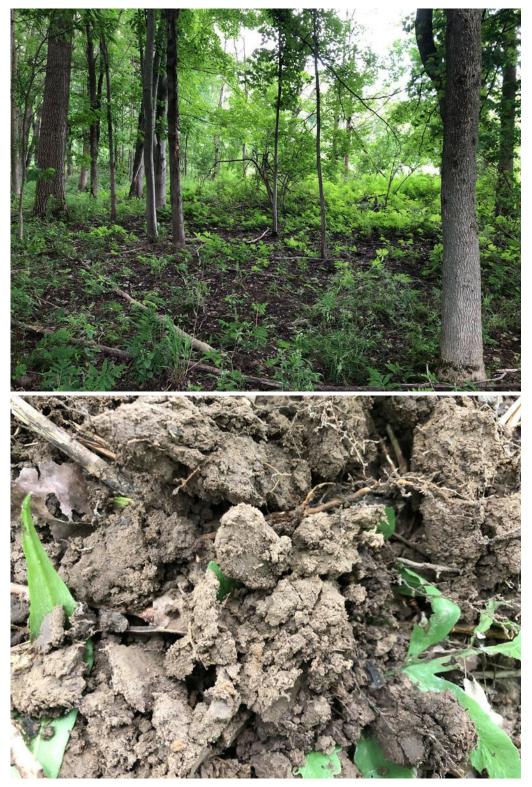
Vegetation Photos

ree Stratum (Plot size: <u>30 ft</u>)		Dominant Species?	Indicator Status	Dominance Test worksheet: Number of Dominant Species That	5	(• •
. Acer rubrum	60	Yes	FAC	Are OBL, FACW, or FAC:		(A)
. Fraxinus pennsylvanica	25	Yes	FACW	Total Number of Dominant Species	5	(B)

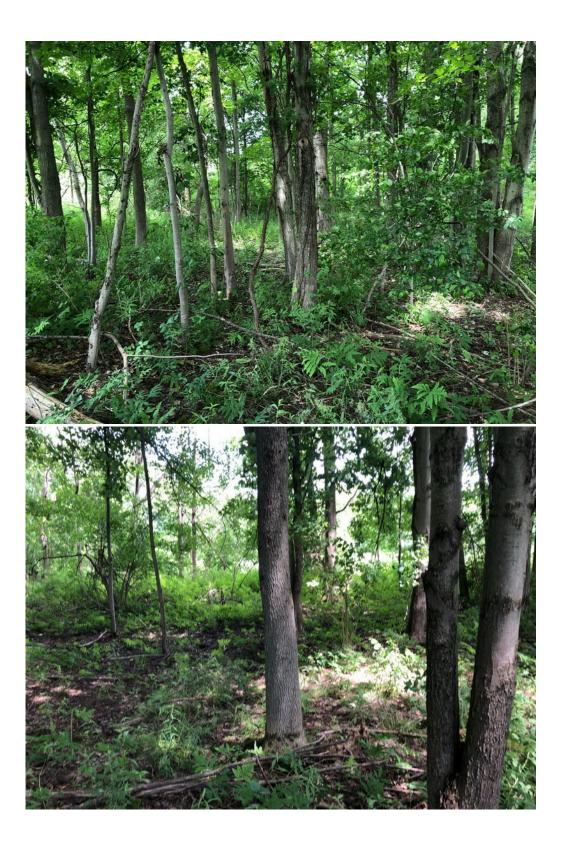
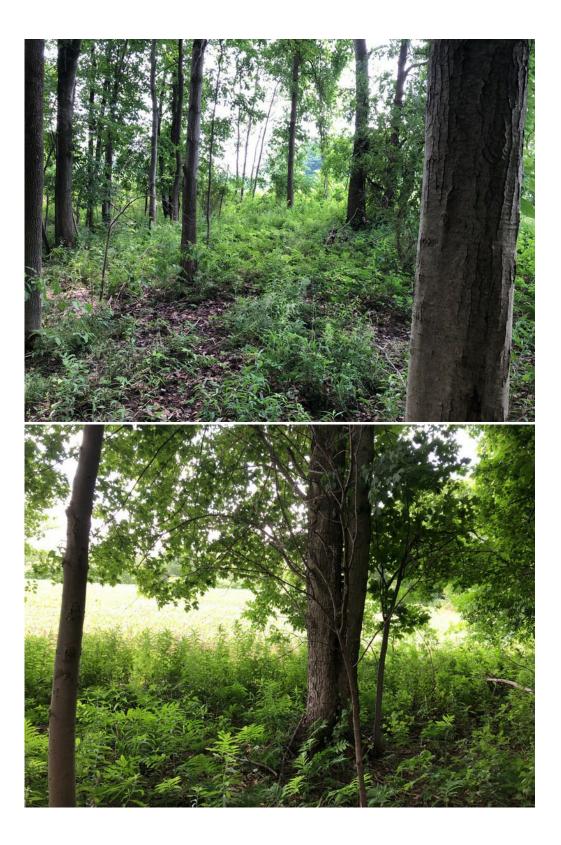
Soil Photos

nches)	Color (moist)	%	Color (moist)	%	Type ¹	Loc ²	Texture	Remarks
- 18	10YR 3/2	95	10YR 5/6	5	С	<u>M</u>	andy Clay Loam	
·		· ·		·				
·				· · ·				
be: C = C	oncentration, D = [Depletio	on, RM = Reduced	l Mat	rix, MS =	Masked Sand Gra	ns. ² Location: PL = Pore	Lining, M = Matrix.
	ndicators:							oblematic Hydric Soils ³ :
Black His Hydroge Stratified Depleted Fhick Da Sandy M Sandy G Sandy Re Stripped	ipedon (A2) stic (A3) n Sulfide (A4) l Layers (A5) l Below Dark Surfa rk Surface (A12) ucky Mineral (S1) leyed Matrix (S4) edox (S5) Matrix (S6) face (S7) (LRR R, M		Depleted Da Redox Depre	y Mir d Ma trix (l Surfa rk Su	eral (F1) trix (F2) F3) ce (F6) rface (F7)	(LRR K, L)	Coast Prairie 5 cm Mucky Dark Surface Polyvalue Be Thin Dark Su Iron-Mangar Piedmont Fl Mesic Spodio Red Parent N	elow Surface (S8) (LRR K, L) urface (S9) (LRR K, L) hese Masses (F12) (LRR K, L, R) oodplain Soils (F19) (MLRA 149B) c (TA6) (MLRA 144A, 145, 149B) Material (F21) y Dark Surface (TF12)

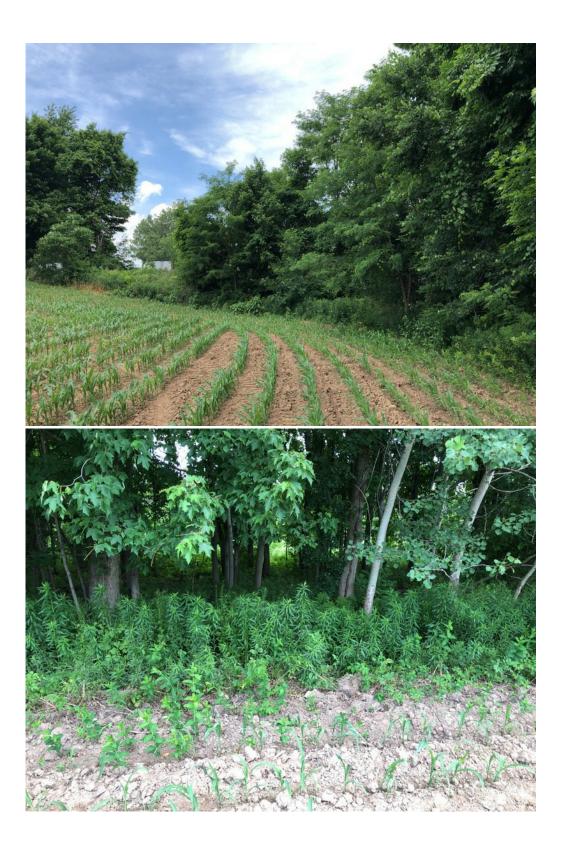
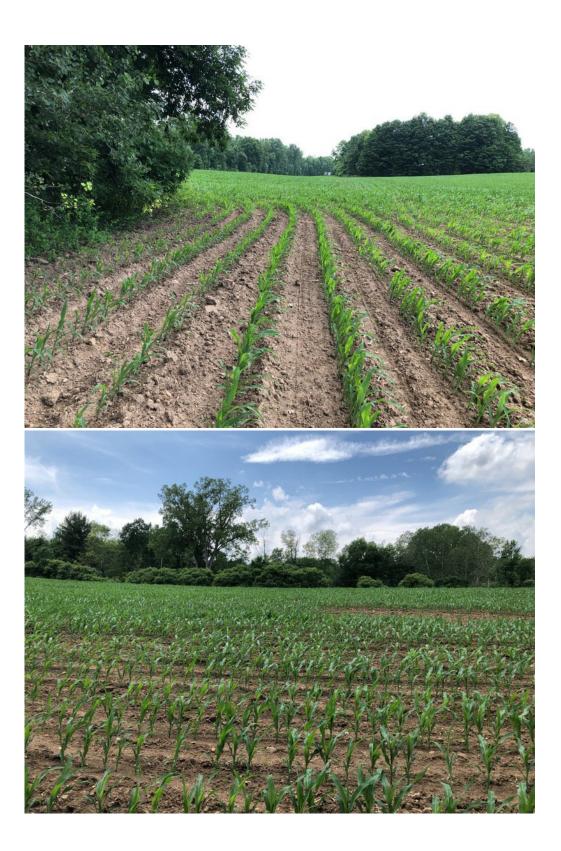
Soil Photos

Depth	Matrix					<u> </u>	-	
nches)	Color (moist)	<u>%</u>	Color (moist)	<u>%</u>	Type ¹	Loc ²	Texture	Remarks
0 - 20	10YR 3/4	100					Silt Loam	
						<u> </u>		
·								
	Concentration D =		n RM = Reduced	Matri	iv MS = I	Masked Sand G	ains 21 ocatio	
	Indicators:	Depietie	n, nivi – Neudceu	matri	1, 1015 - 1			ators for Problematic Hydric Soils ³ :
Histoso			Debaratus De		infaco (C)		1 400)	
	pipedon (A2)					8) (LRR R, MLRA R, MLRA 149B)	2	cm Muck (A10) (LRR K, L, MLRA 149B)
	istic (A3)		Loamy Muck					oast Prairie Redox (A16) (LRR K, L, R)
	en Sulfide (A4)		Loamy Gleye					cm Mucky Peat or Peat (S3) (LRR K, L, R)
	d Layers (A5)		Depleted Ma					oark Surface (S7) (LRR K, L)
	d Below Dark Surfa	ace (A11	-					olyvalue Below Surface (S8) (LRR K, L)

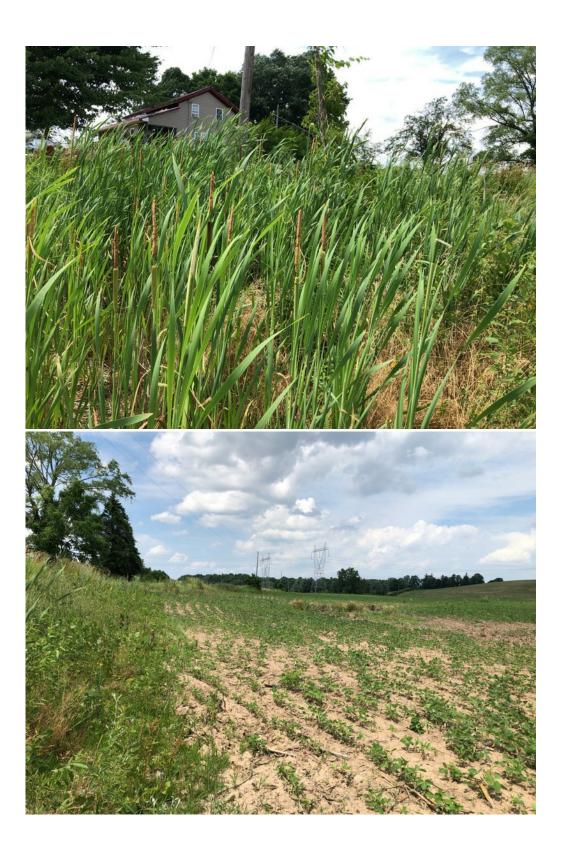
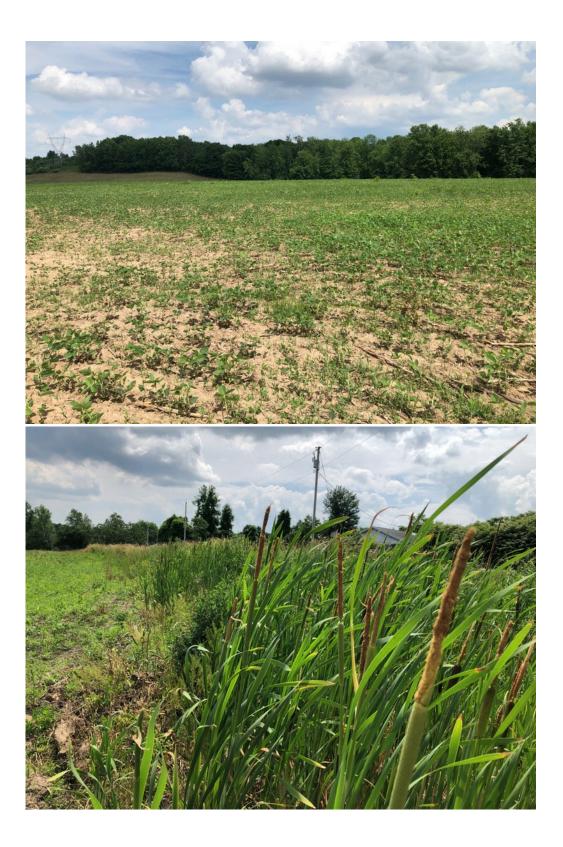
Soil Photos

Redux Depre	:55101	IS (FO)		Piedmont Flo	oodplain Soils (F19) (MLRA 149B)
Stripped Matrix (S6)	-	-						Mesic Spodie	c (TA6) (MLRA 144A, 145, 149B)
	-							Red Parent N	Material (F21)
Indicators of hydrophytic vegetation and wetland hydrology must be present, unless disturbed or problematic. Indicators of hydrophytic vegetation and wetland hydrology must be present, unless disturbed or problematic. Instrictive Layer (if observed): Type: None Depth (inches): Hydric Soil Present?				0.01				Very Shallow	/ Dark Surface (TF12)
strictive Layer (if observed): Hydric Soil Present? Yes _ < No Type: None Hydric Soil Present? Yes _ < No	_ Dark Su	(1111) (LKK K, W		.96)				Other (Expla	in in Remarks)
Type: None Hydric Soil Present? Yes _ No Depth (inches):	dicators	of hydrophytic vege	etation	and wetland hyd	rolog	y must be	e present, unless distu	rbed or problematic.	
Depth (inches):	strictive L	ayer (if observed):

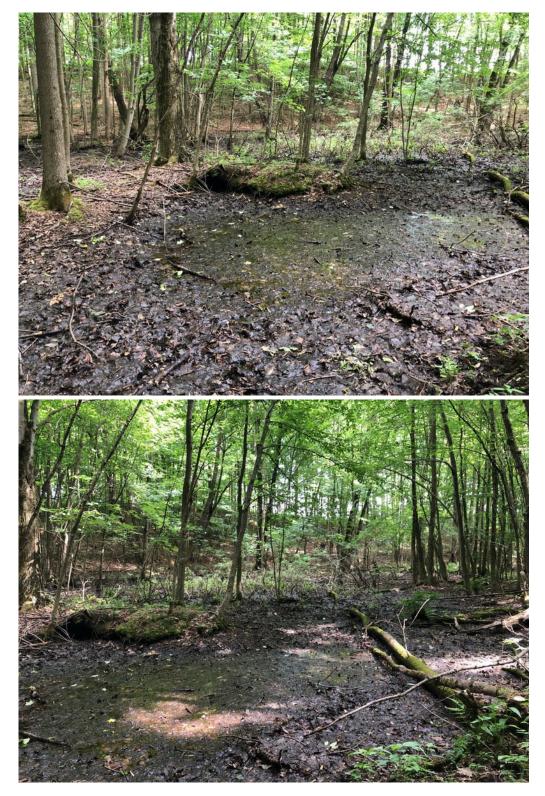
Hydrology Photos

Wetland Hydrology Indicators			
Primary Indicators (minimum	of one is required; check all	that apply)	Secondary Indicators (minimum of two required)
 Surface Water (A1) High Water Table (A2) Saturation (A3) Water Marks (B1) Sediment Deposits (B2) Drift Deposits (B3) Algal Mat or Crust (B4) Iron Deposits (B5) Inundation Visible on Aeria Sparsely Vegetated Concastant 	Aquat Marl I Hydro Oxidi: Prese Recer Thin I al Imagery (B7) Other	r-Stained Leaves (B9) tic Fauna (B13) Deposits (B15) ogen Sulfide Odor (C1) zed Rhizospheres on Living Roots ence of Reduced Iron (C4) nt Iron Reduction in Tilled Soils (C6 Muck Surface (C7) • (Explain in Remarks)	✓ Saturation Visible on Aerial Imagery (C9)
Field Observations:			
Surface Water Present?	Yes No 🟒	Depth (inches):	
Water Table Present?	Yes 🖌 No	Depth (inches):	5 Wetland Hydrology Present? Yes No
Saturation Present?	Yes 🟒 No	Depth (inches):	0
(includes capillary fringe)

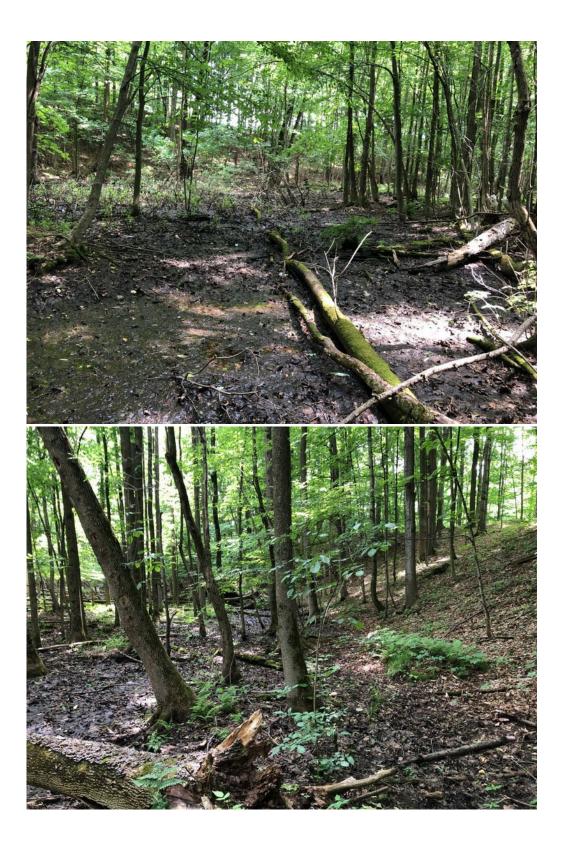
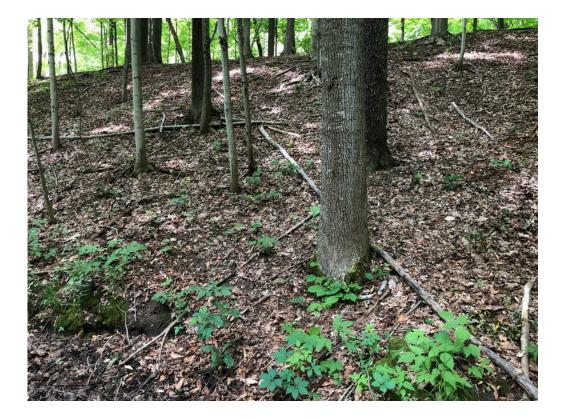
Soil Photos

iches)	Color (moist)	%	Color (moist)	%	Type ¹	Loc ²	Те	exture	Remarks
- 20	10YR 2/2	95	7.5YR 5/4	5	С	M	Sandy	Clay Loam	
 				·					
				·					
pe: C = Con	centration, D = D	epletic	on, RM = Reduced	Mat	rix, MS =	Masked Sand	Grains. ²	Location: PL = Pore l	ining, M = Matrix.
lric Soil Ind	icators:		Polyvalue Be					Indicators for Pro	blematic Hydric Soils ³ :
Stratified L Depleted E Thick Dark Sandy Muc Sandy Gley Sandy Red Stripped M	: (A3) Sulfide (A4) ayers (A5) ielow Dark Surfac Surface (A12) ky Mineral (S1) ved Matrix (S4) ox (S5)	ce (A11	Thin Dark Su Loamy Muck Loamy Gleye Depleted Ma) ✓ Redox Dark S Depleted Dar Redox Depre	y Min d Ma trix (F Surfac rk Sur	eral (F1) trix (F2) -3) ce (F6) rface (F7)	(LRR K, L)	,	5 cm Mucky P Dark Surface Polyvalue Bel Thin Dark Sur Iron-Mangane Piedmont Flo Mesic Spodic Red Parent M	ow Surface (S8) (LRR K, L) face (S9) (LRR K, L) ese Masses (F12) (LRR K, L, R) odplain Soils (F19) (MLRA 149B) (TA6) (MLRA 144A, 145, 149B) aterial (F21) Dark Surface (TF12)

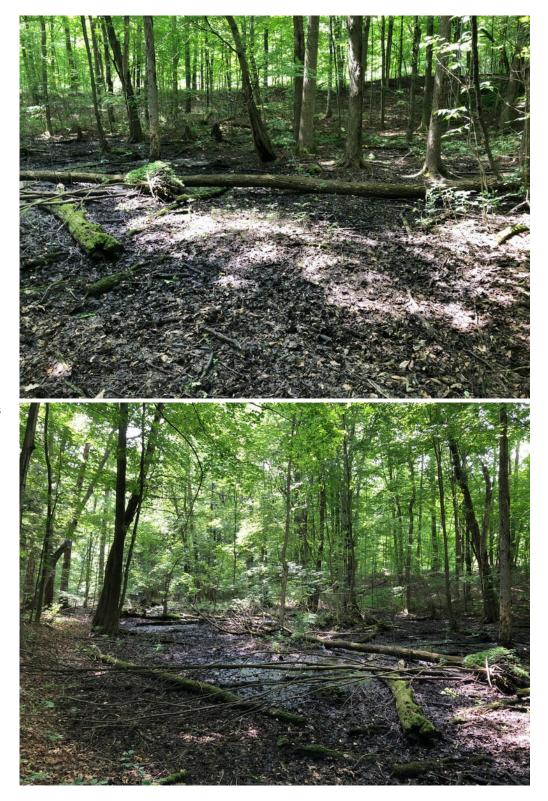
Hydrology Photos

Wetland Hydrology Indicators	:					
Primary Indicators (minimum	of one is required; check all	that apply)		Secondary Indicators (minimum of two required)		
Surface Water (A1) High Water Table (A2) Saturation (A3) Water Marks (B1) Sediment Deposits (B2) Drift Deposits (B3) Algal Mat or Crust (B4) Iron Deposits (B5) Inundation Visible on Aeria Sparsely Vegetated Conca	Aqua Marl I Hydro Oxidi Prese Recer Thin I al Imagery (B7) Other	r-Stained Leaves (B9) tic Fauna (B13) Deposits (B15) ogen Sulfide Odor (C1) zed Rhizospheres on Living Roots ence of Reduced Iron (C4) nt Iron Reduction in Tilled Soils (Co Muck Surface (C7) • (Explain in Remarks)	6)	 Surface Soil Cracks (B6) Drainage Patterns (B10) Moss Trim Lines (B16) Dry-Season Water Table (C2) Crayfish Burrows (C8) Saturation Visible on Aerial Imagery (C9) Stunted or Stressed Plants (D1) Geomorphic Position (D2) Shallow Aquitard (D3) Microtopographic Relief (D4) FAC-Neutral Test (D5)

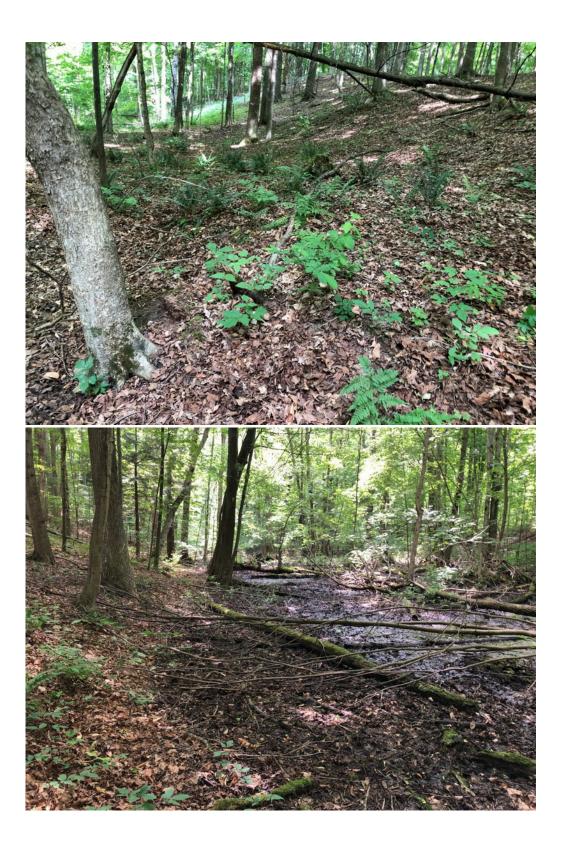
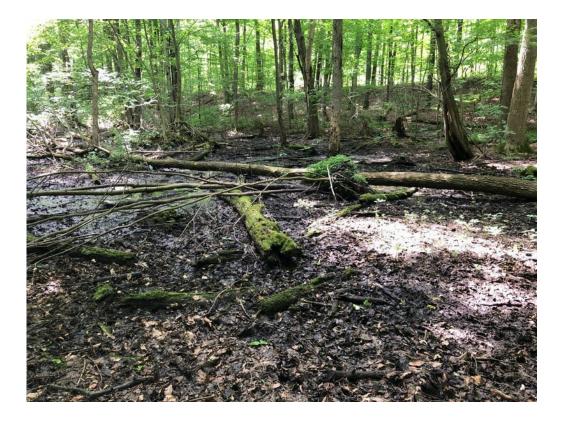
Soil Photos

nches)	Color (moist)	%	Color (moist)	%	Type ¹	Loc ²	Т	exture	Remarks
- 20	10YR 2/2	95	7.5YR 5/4	5	С		Sandy	/ Clay Loam	
		·							
be: C = C	oncentration, D = D	epletio	on, RM = Reduced	Mat	rix, MS =	Masked Sa	nd Grains.	² Location: PL = Pore l	ining, M = Matrix.
ric Soil I	ndicators:		Polyvalue Be					Indicators for Pro	blematic Hydric Soils ³ :
Black Hi Hydroge Stratified Depleted Thick Da Sandy M Sandy G Sandy R Stripped	ipedon (A2) stic (A3) In Sulfide (A4) I Layers (A5) Below Dark Surfac rk Surface (A12) lucky Mineral (S1) leyed Matrix (S4) edox (S5) I Matrix (S6) rface (S7) (LRR R, MI	·	Depleted Dai	y Mir d Ma trix (l Surfa rk Su	eral (F1) trix (F2) -3) ce (F6) face (F7)	(LRR K, L)	+>U)	5 cm Mucky P Dark Surface Polyvalue Bel Thin Dark Sur Iron-Mangane Piedmont Flo Mesic Spodic Red Parent M	ow Surface (S8) (LRR K, L) face (S9) (LRR K, L) ese Masses (F12) (LRR K, L, R) odplain Soils (F19) (MLRA 149B) (TA6) (MLRA 144A, 145, 149B) aterial (F21) Dark Surface (TF12)

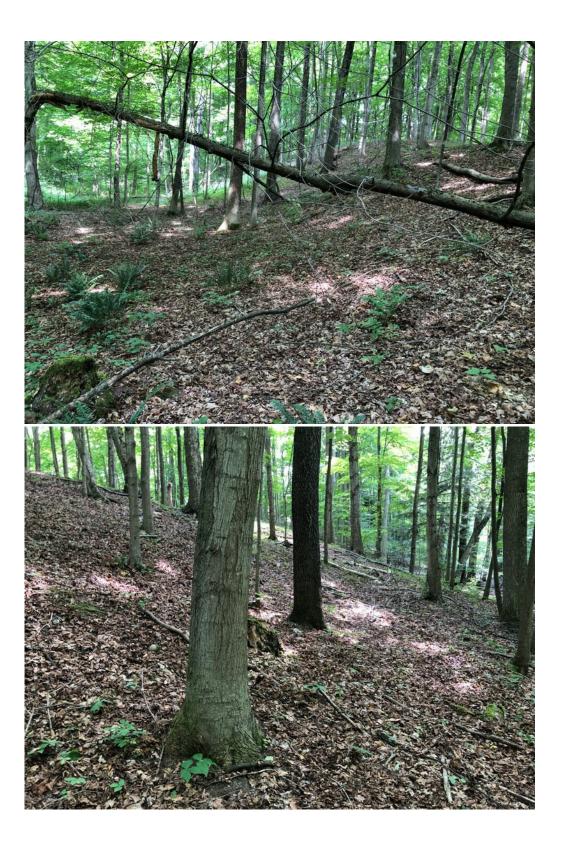
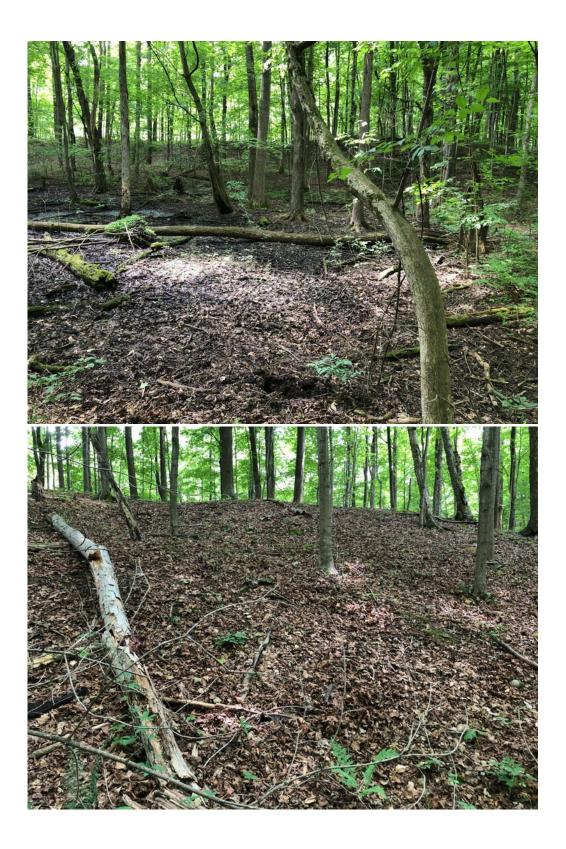
Soil Photos

inches)	Color (moist)	%	Color (moist)	%	Type ¹	Loc ²	Textu	ıre	Remarks
0 - 13	10YR 4/2	100					Sandy L	Loam	
		·				·			
						·			
	oncentration, D = I	Depletio	n, RM = Reduced	Mat	rix, MS =	Masked	Sand Grains. ² l		Pore Lining, M = Matrix.
/ dric Soil Histosol	ndicators:		Polyvalue Bel	ov. C	urface (C	o) <i>(</i> ן חח ר			r Problematic Hydric Soils ³ :
Histic Ep Black Hi Hydroge Stratifie Deplete Thick Da Sandy M Sandy C Sandy R Sandy R Dark Su	hipedon (A2) stic (A3) en Sulfide (A4) d Layers (A5) d Below Dark Surfa rrk Surface (A12) lucky Mineral (S1) leyed Matrix (S4) edox (S5) I Matrix (S6) rface (S7) (LRR R, N	ace (A11) ILRA 149	Thin Dark Sur Loamy Mucky Depleted Mat) Redox Dark S Depleted Dar Redox Depres	rface / Mir d Ma trix (l surfa k Su ssior	(S9) (LRR leral (F1) i trix (F2) ⁷ 3) ce (F6) cface (F7) is (F8)	. R, MLRA	A 149B))	Coast Pr. 5 cm Mu Dark Sur Polyvalu Thin Dar Iron-Mar Piedmon Mesic Sp Red Pare Very Sha Other (E)	ck (A10) (LRR K, L, MLRA 149B) airie Redox (A16) (LRR K, L, R) cky Peat or Peat (S3) (LRR K, L, R) face (S7) (LRR K, L) e Below Surface (S8) (LRR K, L) k Surface (S9) (LRR K, L) nganese Masses (F12) (LRR K, L, R) it Floodplain Soils (F19) (MLRA 149B) odic (TA6) (MLRA 144A, 145, 149B) ent Material (F21) llow Dark Surface (TF12) kplain in Remarks)

of hydrophytic veg		and wetland hydr	olog	y must be	e presen	t, unless disturb	ed or problema	atic.
	.ayer (if observed): 								X N Z
	Type: Depth (inches):		None			Hydric	Soil Present?		Yes No 🟒
emarks:									
able to d	ig past 13 inches d	ue to ro	ots

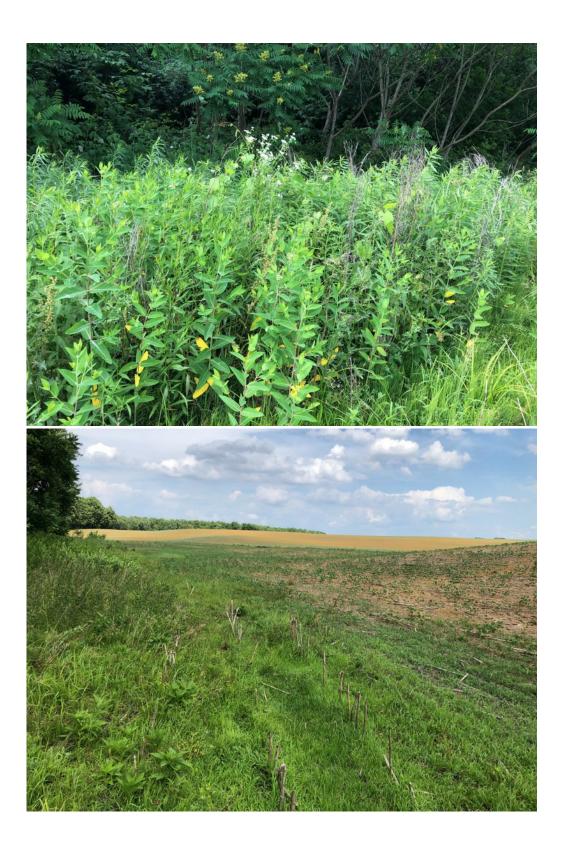
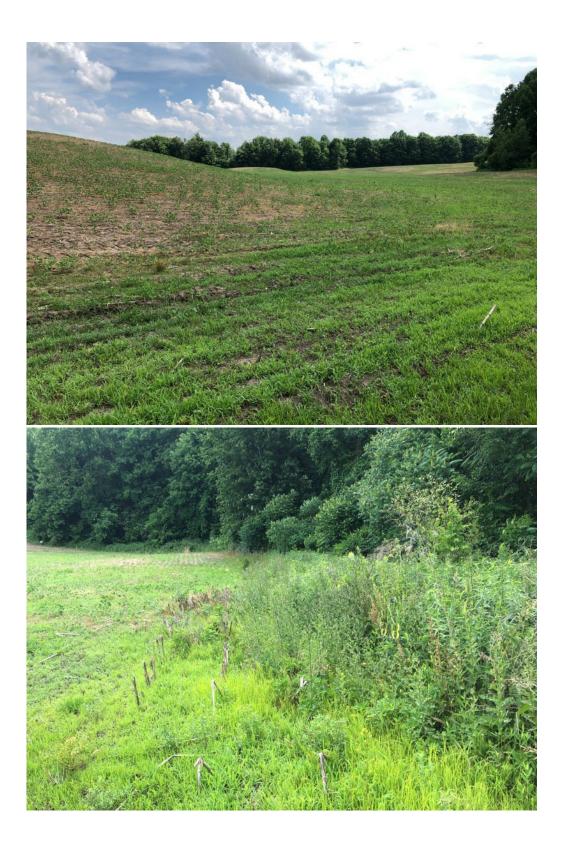
Soil Photos

Depth Mati	rix		Features		nfirm the absence of ir	laicator <i>s</i> ,
nches) Color (ma		Color (moist)	% Type ¹	Loc ²	Texture	Remarks
0 - 18 10YR 2/		5YR 3/4	5 C	<u></u>	Sandy Clay Loam	
			<u> </u>			
			<u> </u>			
			<u> </u>			
			. <u> </u>			
			. <u> </u>			
			<u> </u>			
pe: C = Concentration	ı, D = Depleti	on, RM = Reduced	Matrix, MS	= Masked Sand	Grains. ² Location: PL	= Pore Lining, M = Matrix.
lric Soil Indicators:					Indicators	s for Problematic Hydric Soils ³ :
Histosol (A1)				(S8) (LRR R, ML F		Muck (A10) (LRR K, L, MLRA 149B)
Histic Epipedon (A2)		Thin Dark Su	rface (S9) (L	rr r, mlra 1498	•	Prairie Redox (A16) (LRR K, L, R)
Black Histic (A3)		Loamy Muck				Mucky Peat or Peat (S3) (LRR K, L, R)
Hydrogen Sulfide (A4		Loamy Gleye)		Surface (S7) (LRR K, L)
Stratified Layers (A5)		Depleted Ma			Polyva	alue Below Surface (S8) (LRR K, L)
Depleted Below Dark					Thin D	Dark Surface (S9) (LRR K, L)
